SPARK BUILDING INSULATES HEATED SLABS FROM FRIGID BALCONIES WITH STRUCTURAL THERMAL BREAKS

SPARK IS A STATE-OF-THE-ART BUILDING near Madison's Capitol — owned by American Family Insurance. The 158,000 sq ft (14,694 sq m) Spark is home to several hundred of American Family's 8,100 employees. It also houses DreamBank, a community space dedicated to the pursuit of dreams, and StartingBlock Madison, an entrepreneurial hub fostering Madison's start-up community, along with the new American Family Insurance Institute for Corporate and Social Impact.

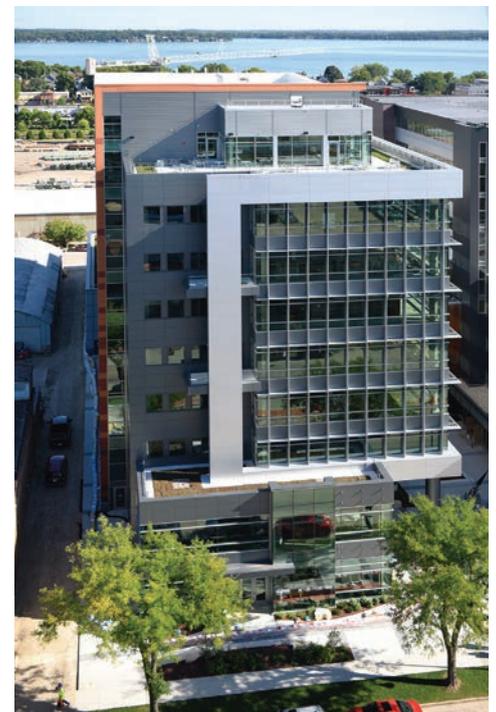
The Spark Building with balconies visible

The Spark's five balconies contain a total of 148 linear feet (44 linear meters) of structural thermal breaks. Joe

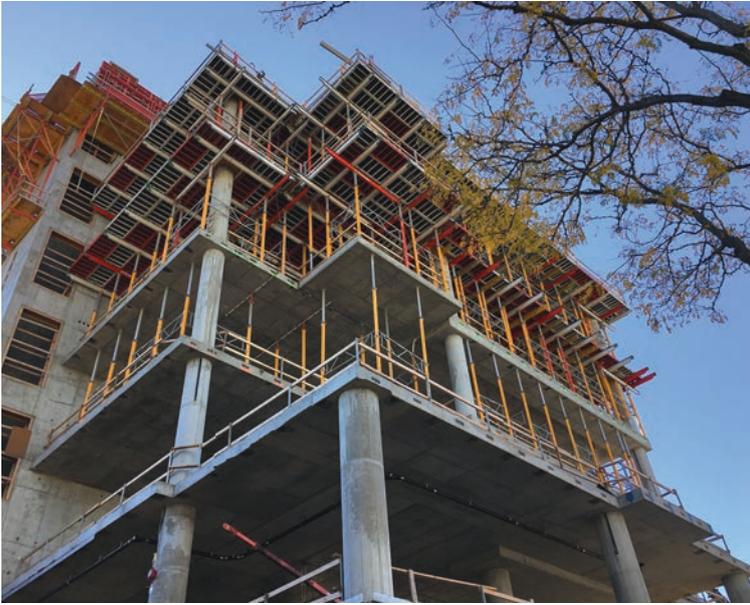
Underside of slabs reveal The Spark's post-tension concrete construction supporting 10 ft (3 m) cantilevered balconies.

Lopera says the thermal breaks worked well with the post-tensioned concrete structure, allowing for the 10 ft (3 m) long and 12 in. (305 mm) thick balcony slabs to freely cantilever, for a more elegant building. “Structural thermal breaks gave me more freedom as a designer,” he adds.

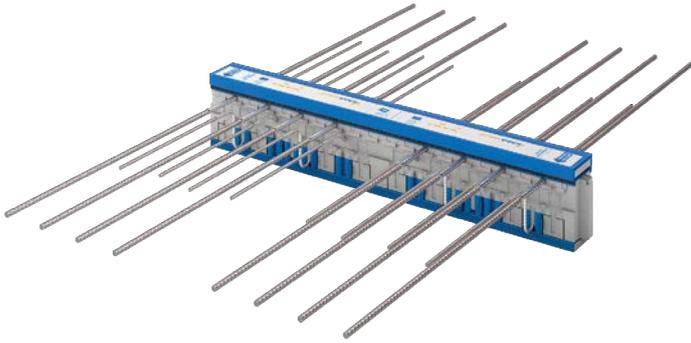
Stainless steel tension and shear rebar of Isokorb® structural thermal break ties into carbon steel rebar of interior and exterior slabs prior to casting.

The design team averted thermal bridging issues at the balconies by installing Schöck Isokorb® Structural Thermal Breaks. Positioned within the building envelope between the interior floor slab and cantilevered balcony slab, they act as continuation of the wall insulation through the concrete floor slab. Most of the cross sectional area typically consisting of concrete and carbon steel is now comprised of a high-performing graphite-enhanced expanded polystyrene block that is less than 2 percent as conductive as concrete. Additional energy savings are derived from the module's stainless steel rebar, which is one-third as conductive as its carbon steel equivalent. Projecting from both sides of the structural thermal break, the rebar is engineered to fully develop into the adjacent concrete components without the need for lapping onto adjacent steel.

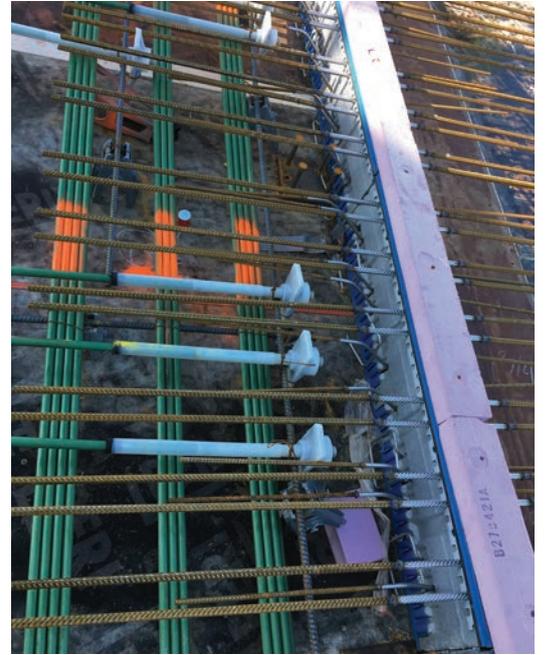
Structural thermal breaks are installed at right angles to the post-tension tendons.

The architect, structural engineer, contractor and structural thermal break supplier conducted early planning and design meetings to determine the best way to install and integrate the structural thermal breaks with the post-tensioning layout.
